ALL THAT REMAINS

THE TRADITIONAL ARCHITECTURE AND
HISTORIC ENGINEERING STRUCTURES
RICHARD B. RUSSELL MULTIPLE RESOURCE AREA

APPENDIX A: THE INVENTORY

PREPARED BY ARCHEOLOGICAL SERVICES BRANCH, ATLANTA
NATIONAL PARK SERVICE

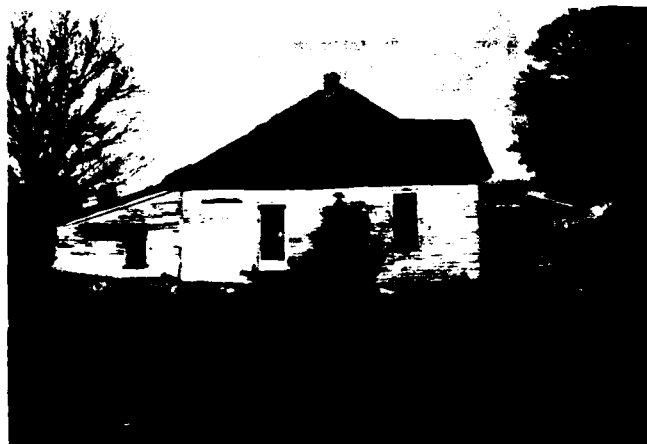
EB418-A

One-story, balloon frame garage 12' x 14'. Gabel roof covered with asphalt shingles, clapboard siding, foundations of brick piers. One room. The structure is in a fair state of preservation. It is associated with 12 other structures as part of a small farm complex. See site EB418-A.

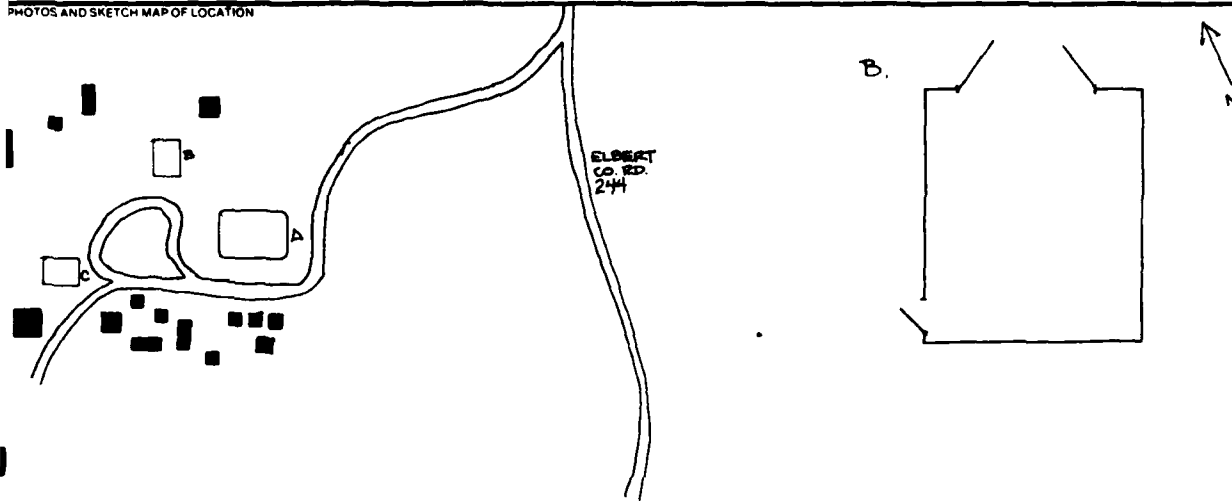
PHOTOS AND SKETCH MAP OF LOCATION

Significance This garage is typical of early twentieth century small farm outbuildings through out the project area and the southeastern United States. For general comments see site EB418-A.

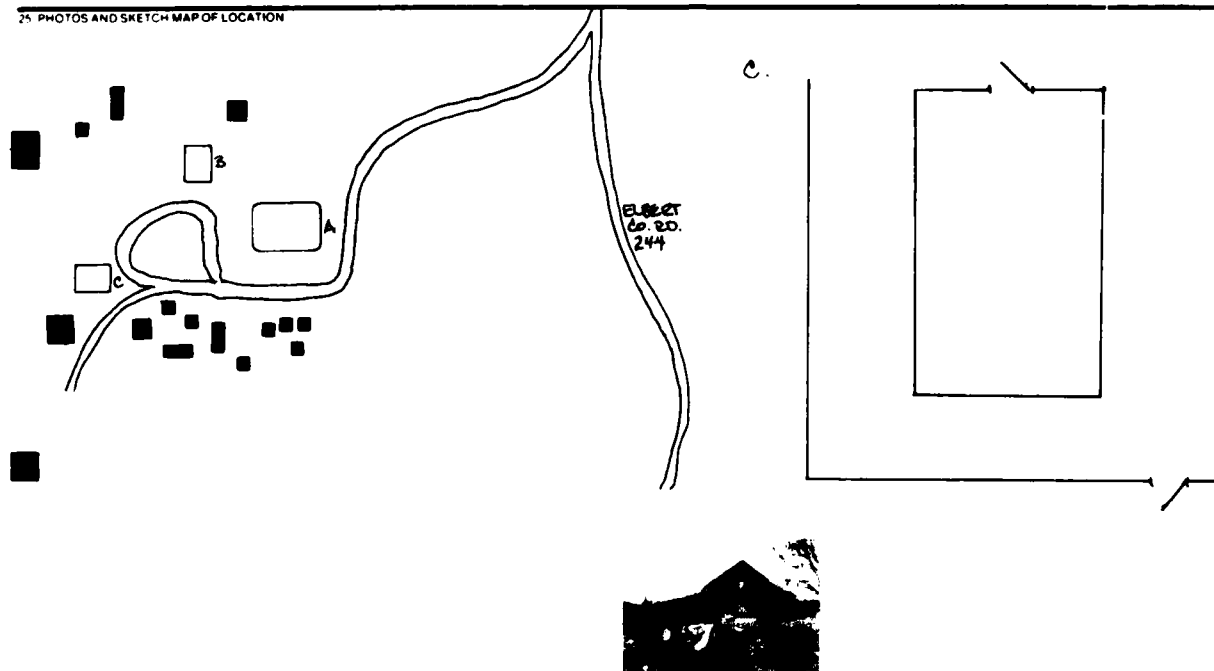
25. PHOTOS AND SKETCH MAP OF LOCATION

17 DESCRIPTION AND BACKGROUND HISTORY INCLUDING CONSTRUCTION DATE(S), HISTORICAL DATE(S), PHYSICAL DIMENSIONS,
MATERIALS EXISTANT EQUIPMENT AND IMPORTANT BUILDERS ENGINEERS ETCOne-story, balloon frame barn, with loft, and post and frame additions, 37' x 36'. Gable roof covered with asphalt
shingles, clapboard siding, no foundations. Original structure one room. The structure is in a fair state of
preservation. It is associated with 12 other structures as part of a small farm complex. See site EB418-A.

Significance This barn is typical of early twentieth century small farm outbuildings throughout the project area and the southeastern United States. For general comments see site EB418-A.

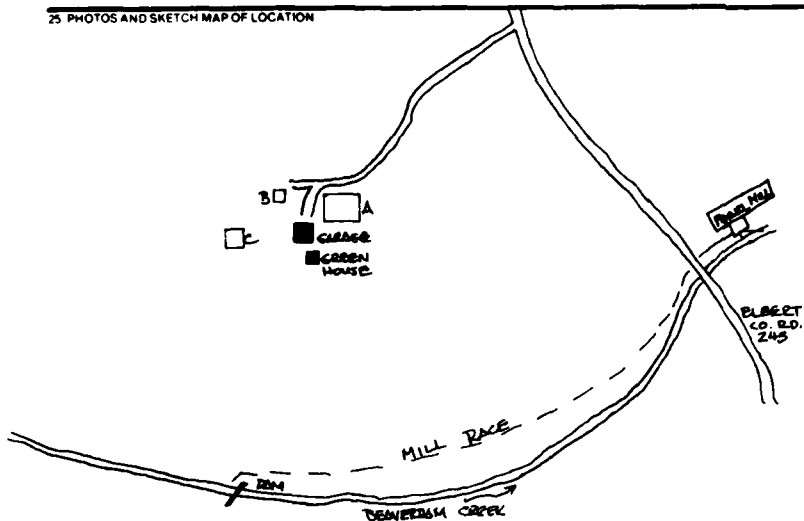
25 PHOTOS AND SKETCH MAP OF LOCATION

This superior home is certainly the most impressive structure in the project area, and is among the few such grand plantation houses remaining in Elbert County. Although not directly impacted by the construction and flooding of the Russell Dam, this house site (already listed on the National Register of Historic Places) will be surrounded on three sides by the waters of the proposed lake, which will reach to within 300 feet of the house. This structure has been included in this inventory because of the overwhelming visual impact of the proposed lake upon the site.

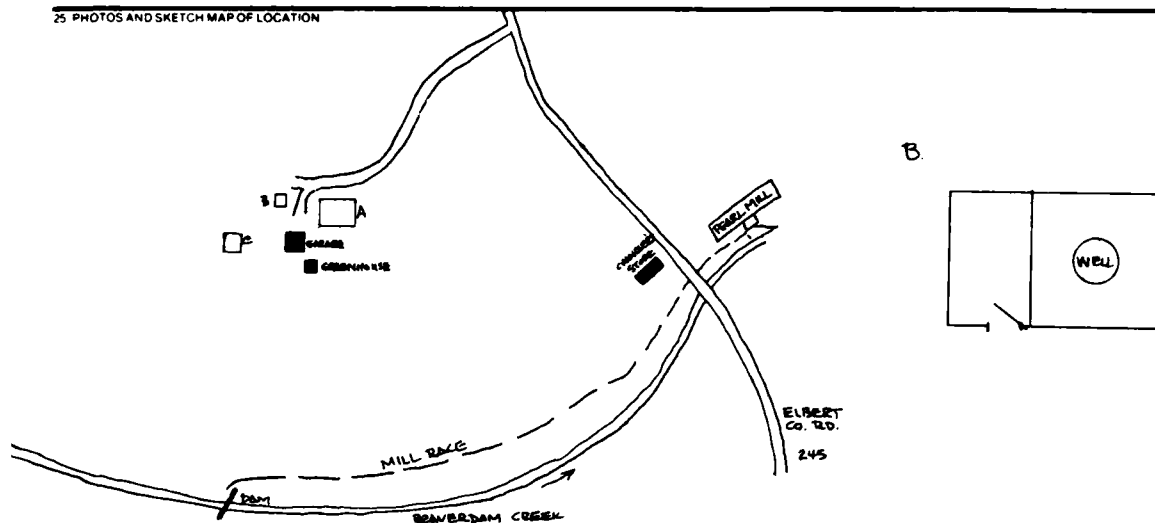
25 PHOTOS AND SKETCH MAP OF LOCATION

One-story, post-and-frame well house, 7' X 12'. Gable roof covered with asphalt shingles; vertical board roof apron, wooden shingles on enclosed portion; fieldstone granite piers as foundations. Plan of an open-sided covering for the well, with added storage room. Interior inaccessible. This structure is in a fair state of preservation and could easily be restored. Associated with this structure are three other structures. See EB500-A for general comments.

This well house is a unique structure within the project area, although the singular nature of this structure derives completely from the addition of the storage room at rear. See EB500-A for general comments.

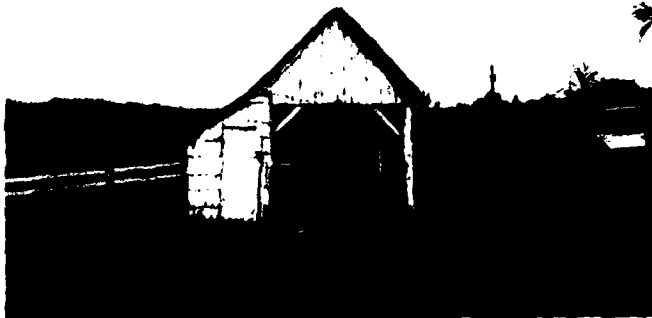
EB500-B (Continued)

This small barn is typical of such structures found throughout the project area and in the surrounding regions. See EB500-A for associated significance.

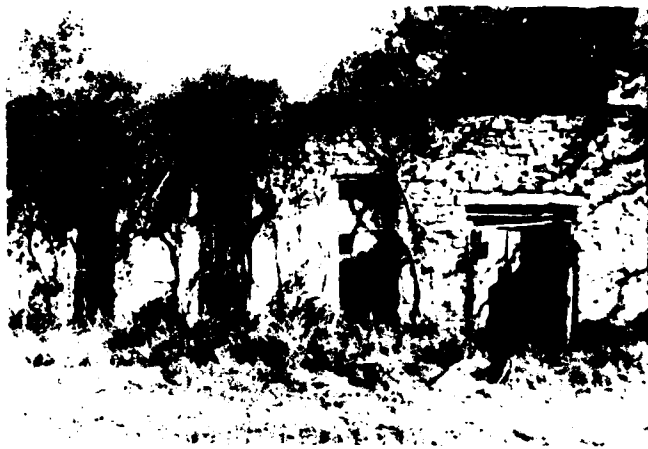
Mill
Site

18 ORIGINAL USE										PRESENT USE										ADAPTIVE USE																			
Grist Mill and Cotton Mill										Ruins										Reservoir																			
19 REFERENCES - HISTORICAL REFERENCES PERSONAL CONTACTS AND/OR OTHER																																							
See HABS report "The Industrial History of the Russell Project Area"																																							
20 URBAN AREA 40,000 SQ FT OR MORE? <input type="checkbox"/> YES <input checked="" type="checkbox"/> NO										21 NERS Region										22 PUBLIC ACCESSIBILITY <input type="checkbox"/> YES LIMITED <input type="checkbox"/> YES UNLIMITED <input checked="" type="checkbox"/> NO <input type="checkbox"/> UNKNOWN										23 EDITOR INDEXER									
24 LOCATED IN AN HISTORIC DISTRICT? <input type="checkbox"/> YES <input checked="" type="checkbox"/> NO										NAME										DISTRICT NO

XXXXXXXXXXXX Southern mill design and technology.

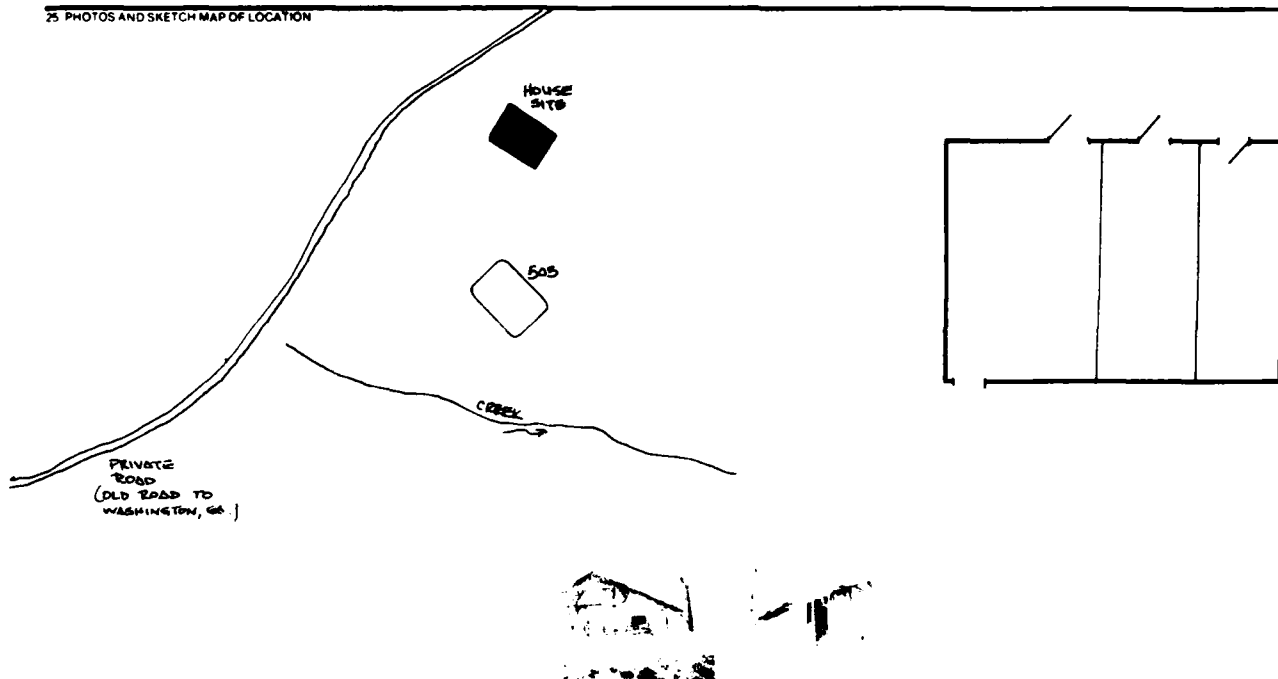
25 PHOTOS AND SKETCH MAP OF LOCATION

This is a typical example of a late nineteenth century barn found throughout the project area and the Southeastern United States. It is the only surviving structure from a small farm complex, once located on the same site.

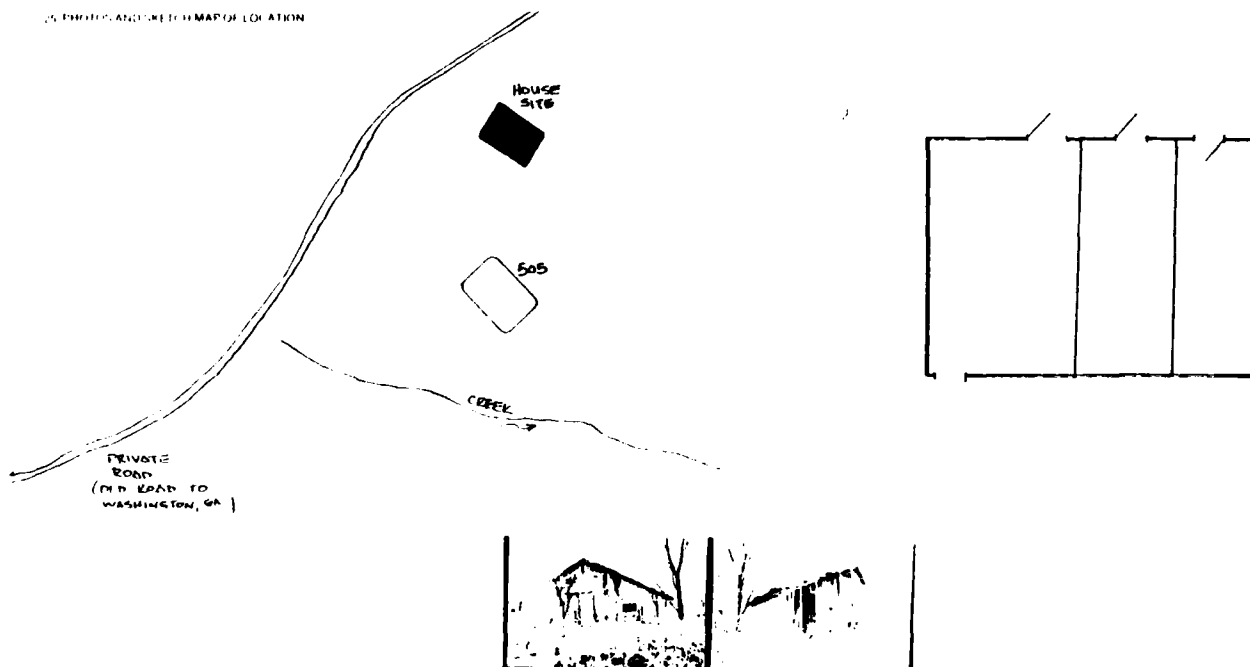
24. PHOTOGRAPH AND KEY TO MAP OF LOCATION

This is a typical example of a late nineteenth century barn found throughout the project area and the Southeastern United States. It is the only surviving structure from a small farm complex, once located on the same site.

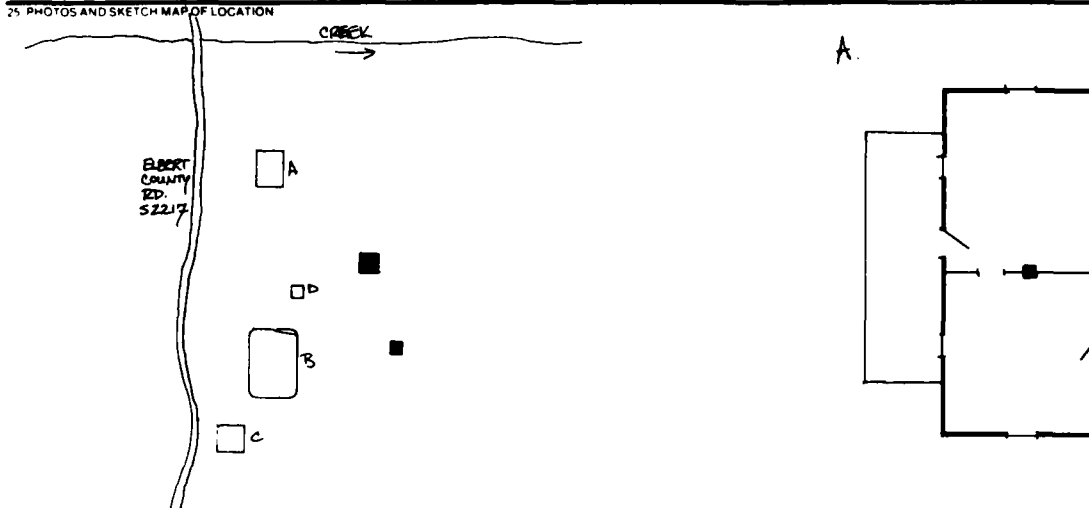
25 PHOTOS AND SKETCH MAP OF LOCATION

Significance This structure is typical of small tenant dwellings found throughout the project area and the southeastern United States. It is adjacent to a similar tenant house (510 B). Though somewhat deteriorated, this structure contains much of its original fabric and integrity, and could be easily preserved.

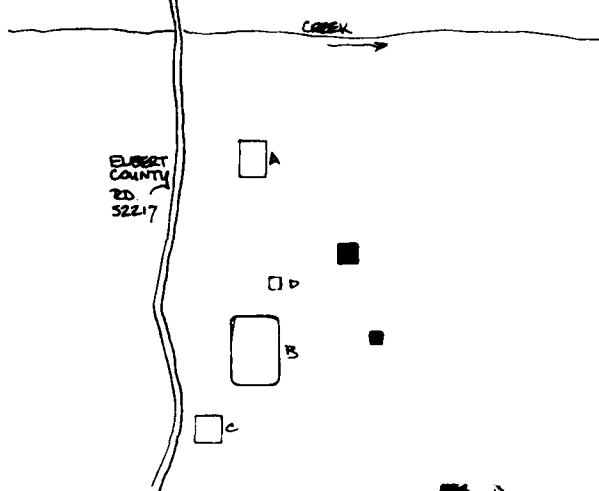
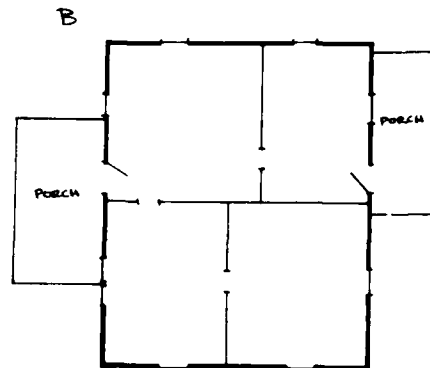
25 PHOTOS AND SKETCH MAP OF LOCATION

This structure is typical of small tenant dwellings found throughout the project area and the southeastern United States. It is adjacent to a similar tenant house (510 A). Though much of the original interior fabric remains intact, some structural deterioration has taken place.

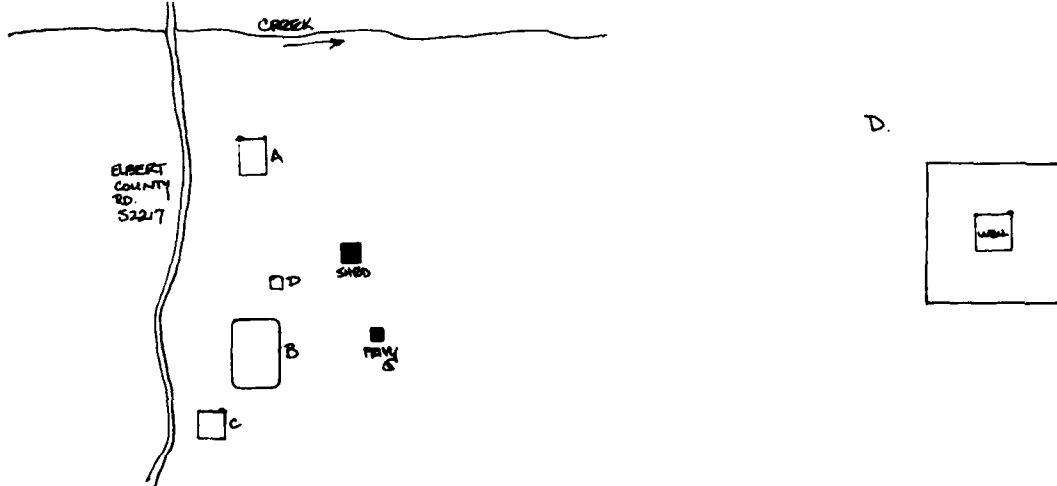
25 PHOTOS AND SKETCH MAP OF LOCATION

This structure is typical of well houses found throughout the project area and the southeastern United States, and is in a good state of preservation.

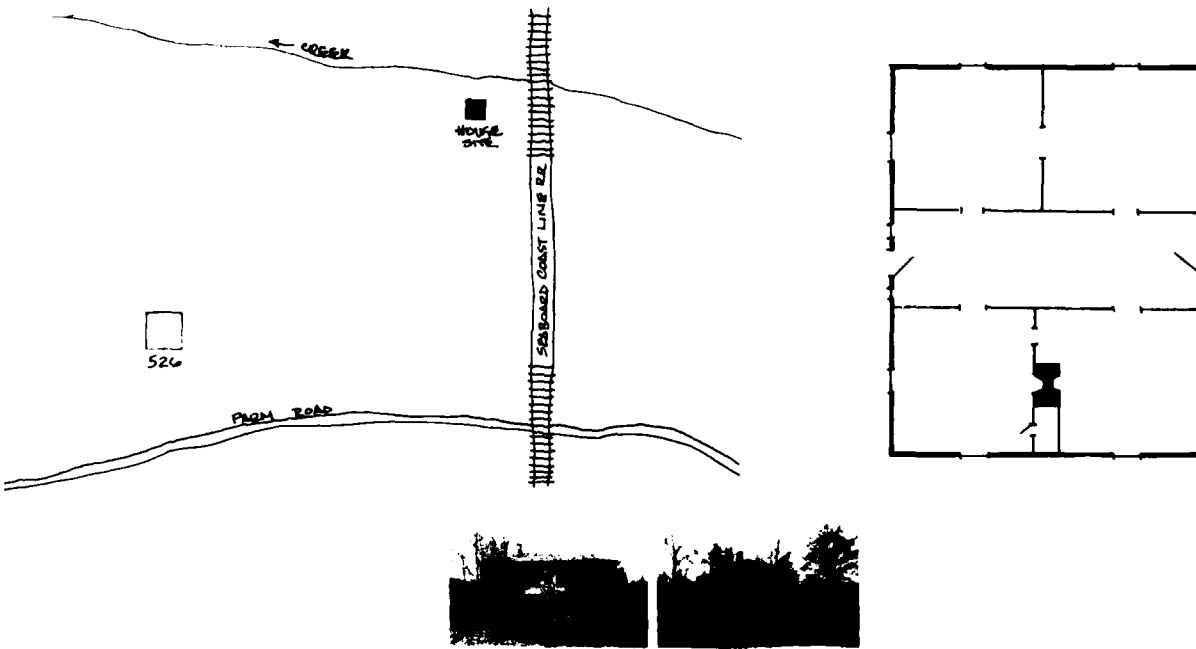
24. PHOTOS AND SKETCH MAP OF LOCATION

This structure is an interesting example of a small tenant dwelling, similar to other structures found throughout the southeastern United States. The unusual characteristic of the low hip roof makes this structure unique in the project area, though somewhat less unique in the surrounding regions. This structure has been badly damaged due to vandalism and neglect and is deteriorating rapidly, thereby compromising any preservation effort.

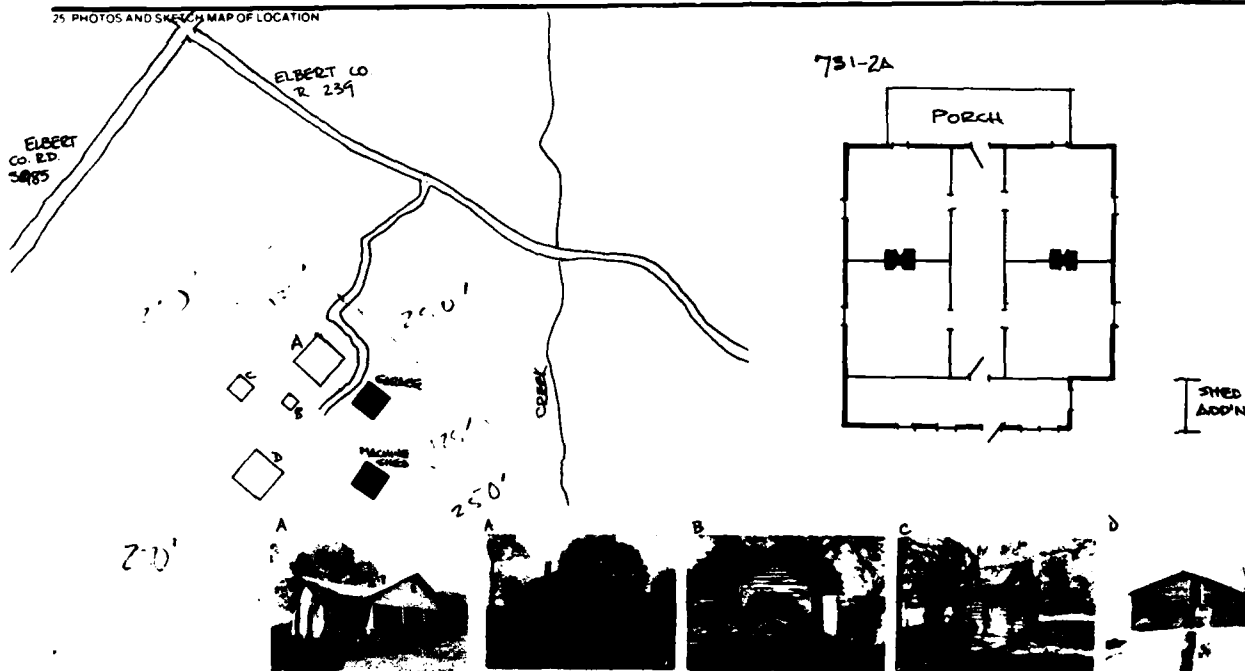
This early twentieth century farm complex is typical of such complexes throughout the project area and the Southeastern United States. However, such a well-preserved complex is rather unusual. The complex is associated with Site EB731-1 through single-family ownership.

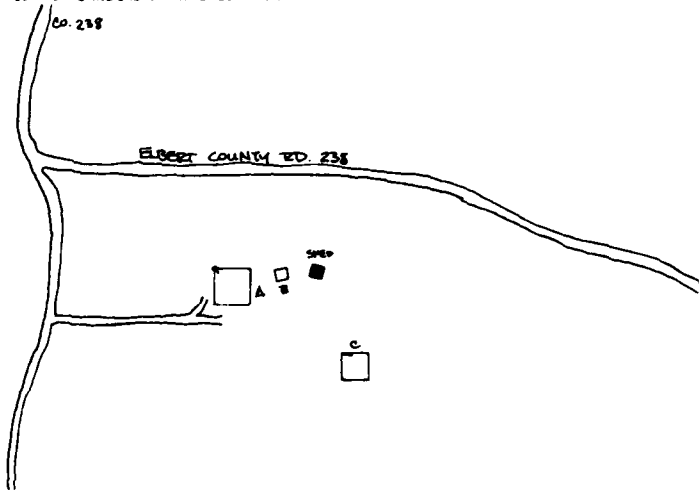
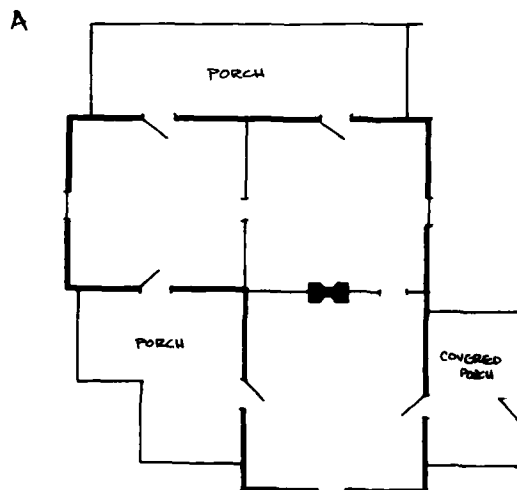
25. PHOTOS AND SKETCH MAP OF LOCATION

Significance This small dwelling is an example of a typical post-Civil War farmhouse, found throughout the project area and the southeastern United States. This structure is in a good state of repair, and appears to contain much of its original fabric.

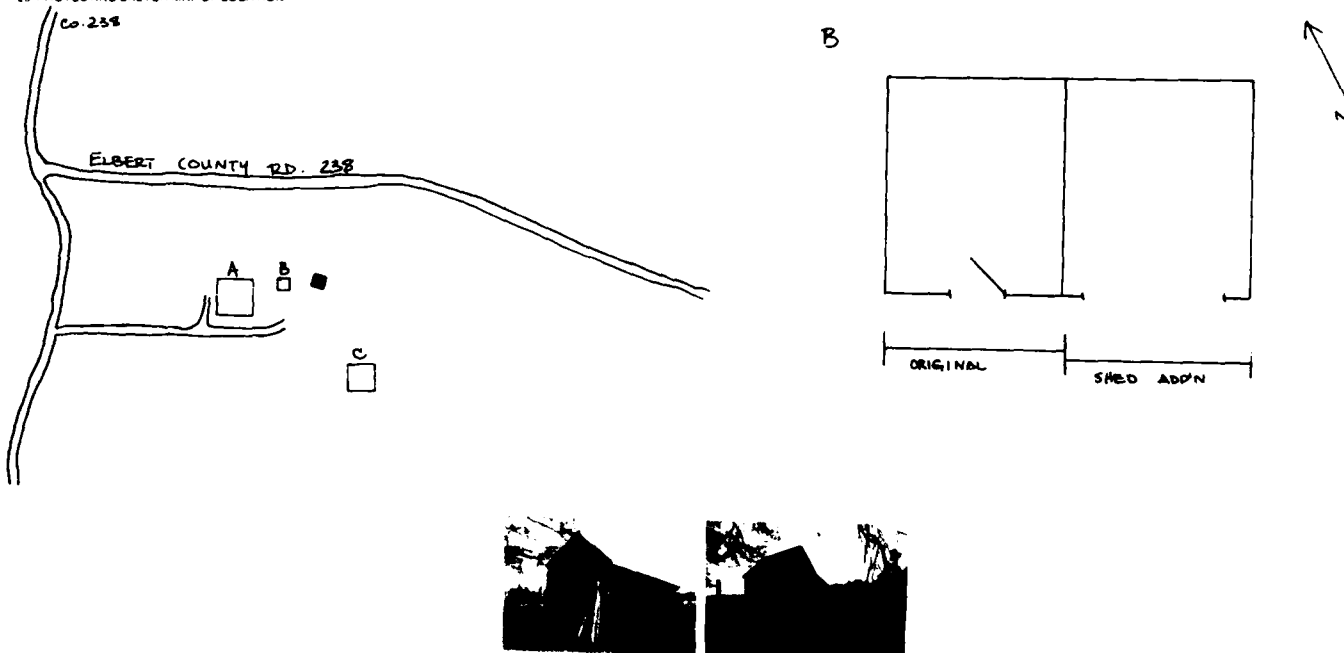
25 PHOTOS AND SKETCH MAP OF LOCATION

Significance Small storage sheds and barns of this type are found throughout the project area and the southeastern United States.

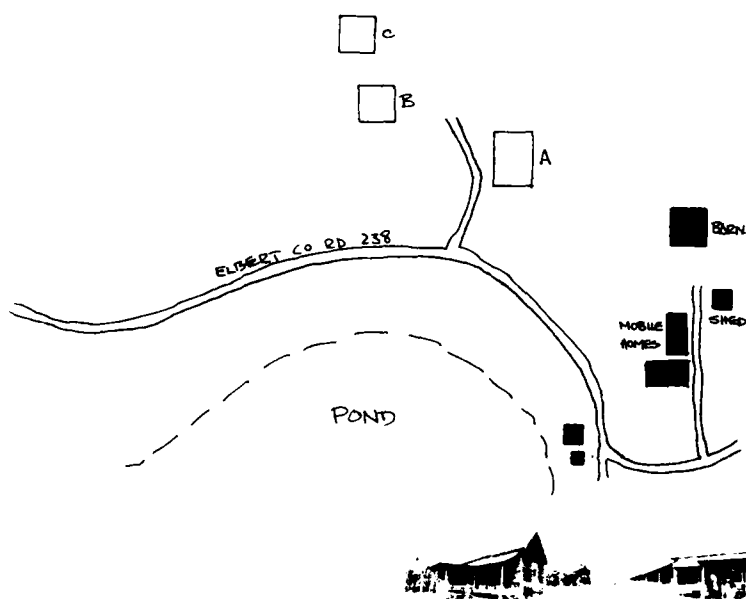
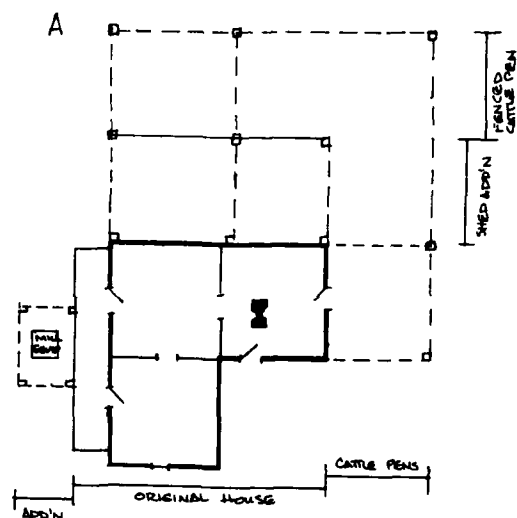
This dwelling is typical of small post-Civil War farm houses located throughout the project area and the Southeastern United States. The adaptation of the structure from house to barn exemplifies the way in which farm structures in this area are altered to meet changing needs. The associated barns, which have undergone similar alterations, are contemporary to this house, and formed a typical small farm complex for the region.

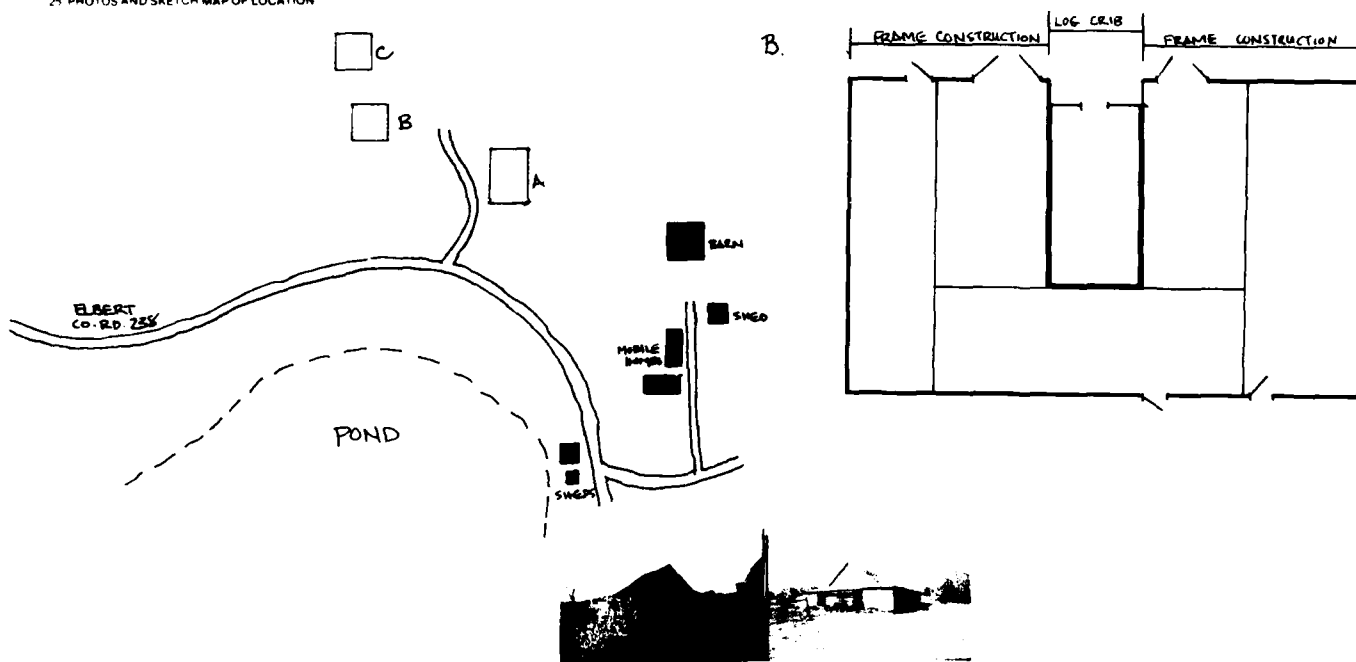
This barn is an unusual example of construction within the project area and in the surrounding regions. The use of saddle-notched logs to form a crib within the structure for the purpose of hay or corn storage appears to be quite singular. Despite additions to the original structure, most of the original fabric remains intact.

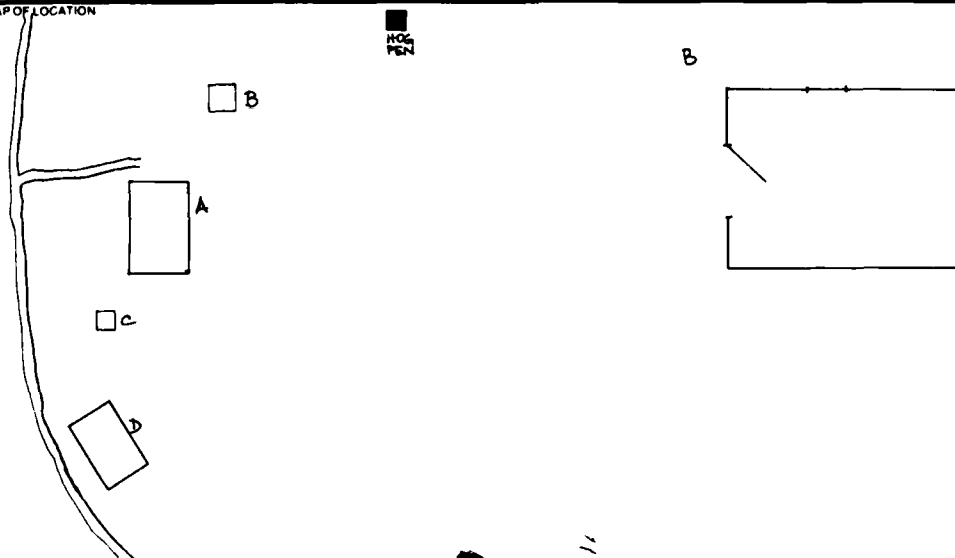
25 PHOTOS AND SKETCH MAP OF LOCATION

Significance This smoke house is a good example of a typical late nineteenth century farm outbuilding, seen throughout the project area and the southeastern United States (See EB1515-A).

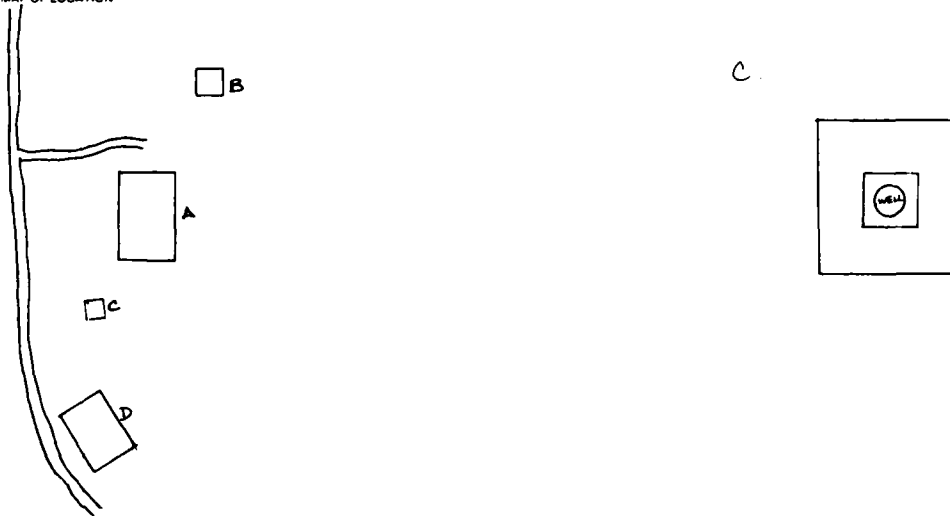
25 PHOTOS AND SKETCH MAP OF LOCATION

Significance This well house is typical of many such structures built in the nineteenth and early twentieth centuries throughout the project area and surrounding region.

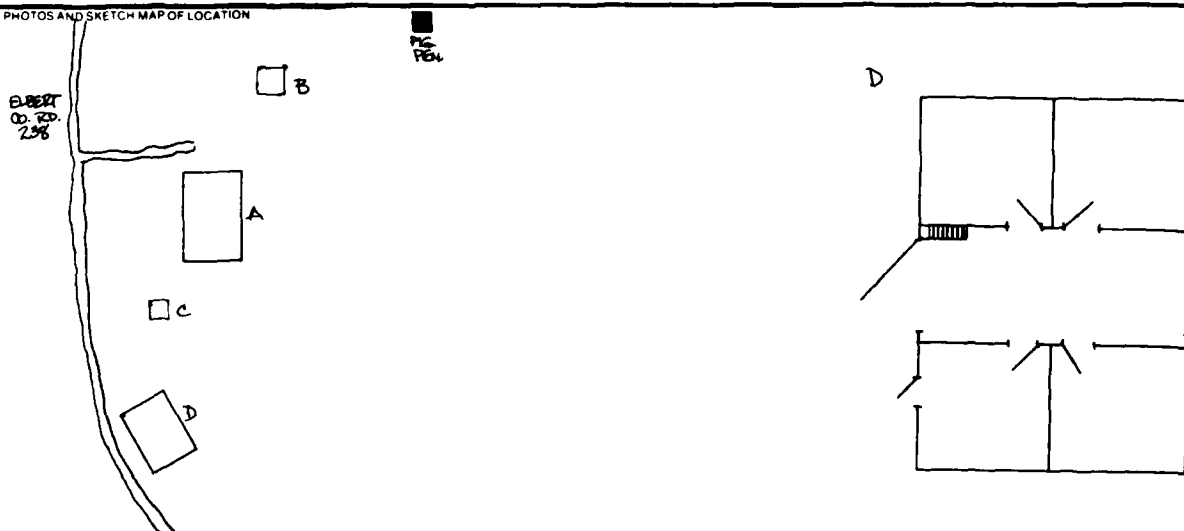
25 PHOTOS AND SKETCH MAP OF LOCATION

Significance According to informant evidence this barn was moved from an early local mill site to its present location, CA 1910. The site and construction of the barn indicates that the original barn, CA. 1840, was radically altered through the relocation process, in effect building a new barn from old parts.

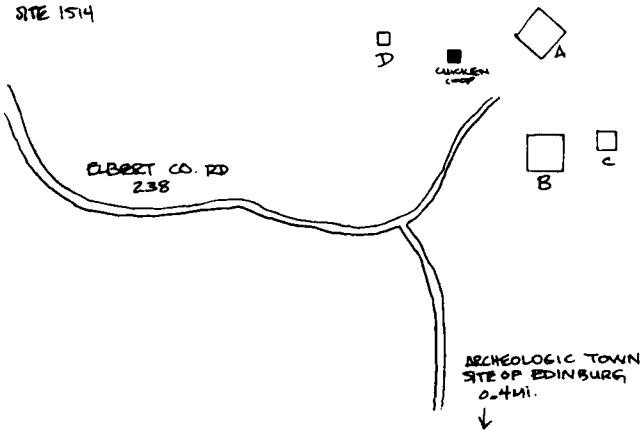
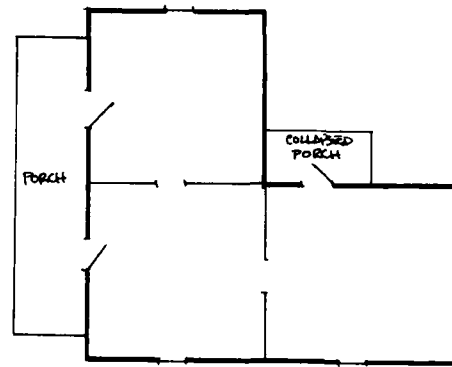
SITE 1514

Significance This small house is an example of a typical dwelling for a late-nineteenth century farm, seen throughout the project area and the southeastern United States. The current use of this structure as a storage building for farm products is resulting in the increasing deterioration of its original fabric. It is associated with three outbuildings, comprising a typical late-nineteenth century small farm complex.

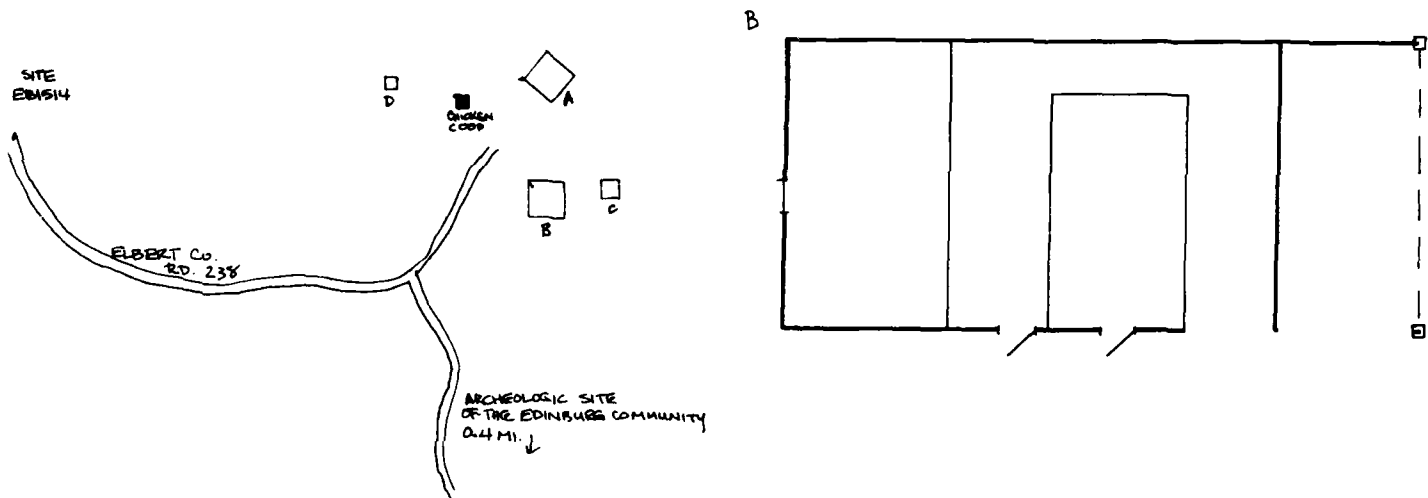
PHOTOS AND SKETCH MAP OF LOCATION

Significance This small barn is typical of late nineteenth century farm outbuildings found throughout the project area and the southeastern United States. (See EB1575-A)

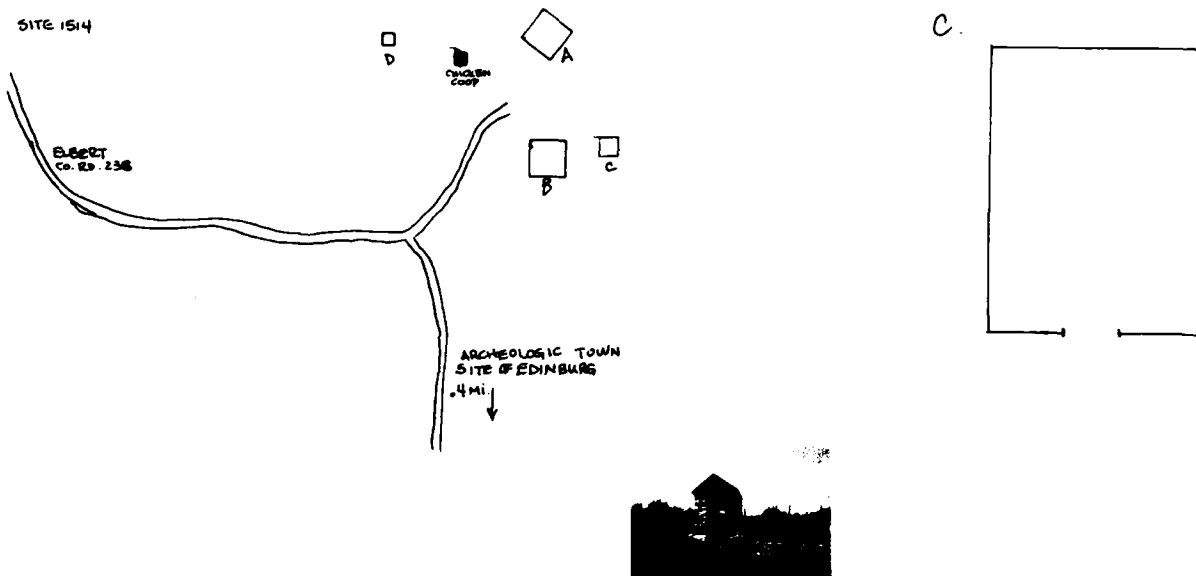
25 PHOTOS AND SKETCH MAP OF LOCATION

Significance This storage barn is typical of small outbuildings on late nineteenth century farms found throughout the project area and the southeastern United States. (See EB1515-A)

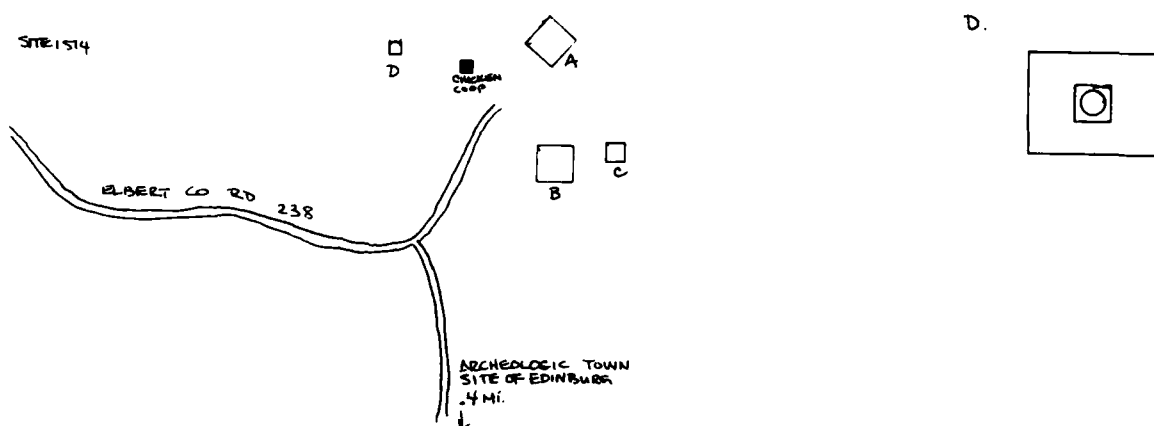
25 PHOTOS AND SKETCH MAP OF LOCATION

Significance This well house is a typical example of many such structures throughout the project area and surrounding regions. Much of the fabric is in place, but is greatly deteriorated through neglect. See EB1515-A for general comments.

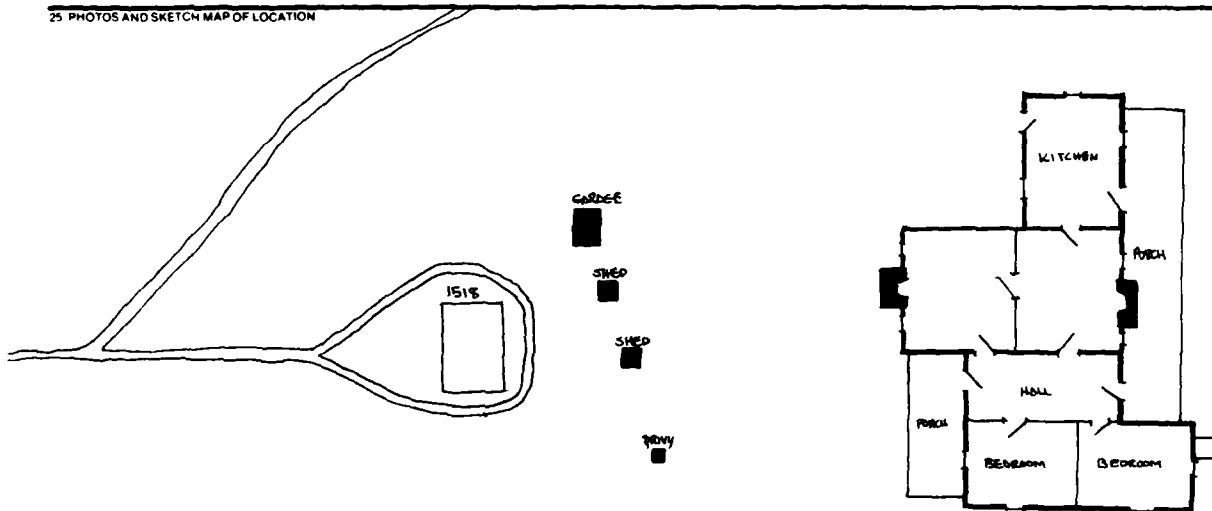
25 PHOTOS AND SKETCH MAP OF LOCATION

Significance This small farm house has been in the Gully Family for approximately seventy-one years, and displays two radically different but well preserved periods of architectural construction. The core of this home was built CA. 1820, and contains a good deal of original fabric despite being greatly altered from its intended appearance. Additions to the house were undertaken CA. 1908, according to informant evidence, which included the partial removal of the second story of the original home. The fabric of the early twentieth century additions remains intact and in excellent repair.

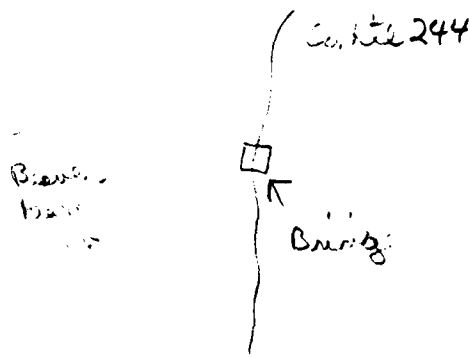
A turn-of-the-century Pratt through truss that is of local significance in the context of transportation and commerce. It is also a regionally significant example of a bridge technology which was once quite common but is rapidly disappearing.

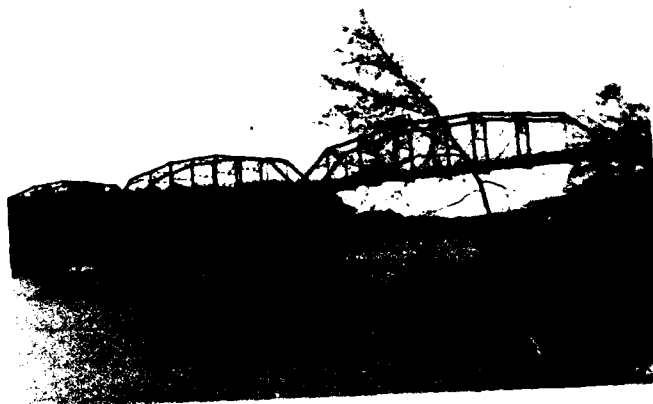
17 DESCRIPTION AND BACKGROUND HISTORY INCLUDING CONSTRUCTION DATE(S), HISTORICAL DATE(S), PHYSICAL DIMENSIONS, MATERIALS, EXTANT EQUIPMENT AND IMPORTANT BUILDERS, ENGINEERS, ETC. The structure is a three span, pin connected Camelback Through Truss. Each truss span is 161 feet long, 19 wide and supported on reinforced concrete piers founded on bedrock. The approach spans are 75 feet long. The "Sander's Ferry Bridge" was built jointly by Elbert County, Ga. & Anderson County, S.C. at a cost of \$82,000. It was the only non-toll bridge connecting Anderson County with Georgia. Built by the Austin Bridge Company of Atlanta, the bridge was formally opened March 17, 1927. The structure is a near classic example of a bridge using the "American System" of pin connections.

Significance A regionally significant bridge built in response to the automobile surge of the 1920's. It is an excellent example of the "American System" of pin connections as applied to bridges.

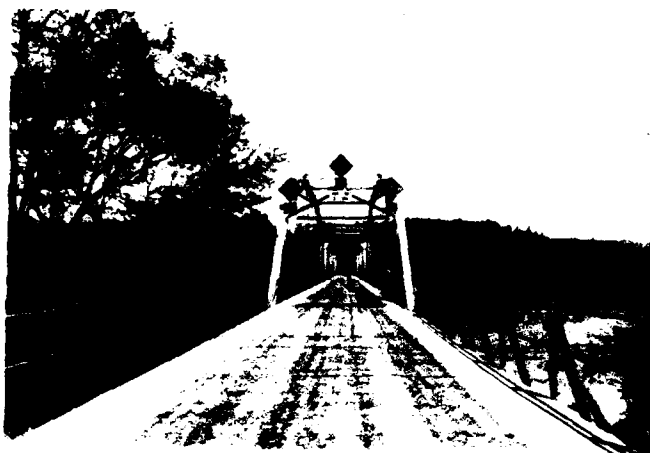
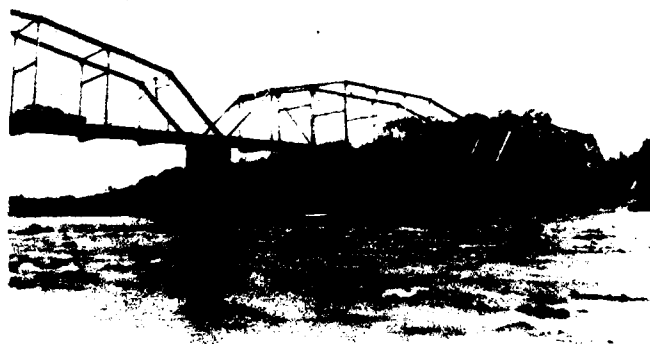
MATERIALS EXTANT EQUIPMENT AND IMPORTANT BUILDERS ENGINEERS ETC Structure is a three span, pin-connected Camelback through truss bridge with approach ramps. Fabricated out of steel, the trusses are 178 feet long and composed of eyebar tension members and laced channel compression members. They are supported on reinforced concrete piers founded on bedrock. The approach ramps have 73 foot spans. The bridge is a well preserved example of a Camelback Truss that remains relatively unaltered. It exhibits, in almost classic form, the "American System" of pin connections made popular in the late 19th and early 20th centuries.

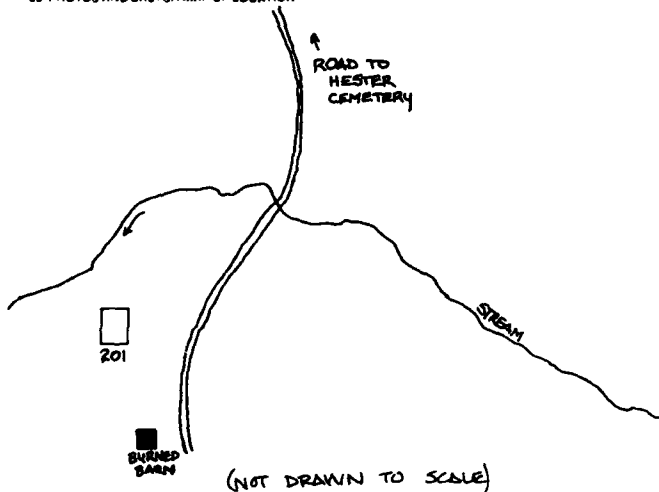
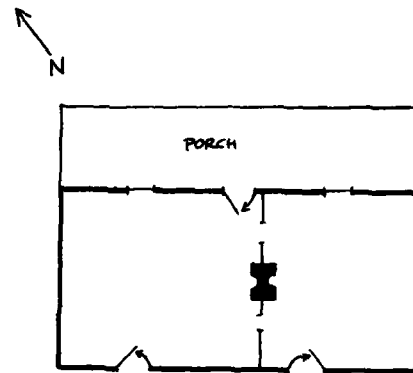
One-story, balloon-frame dwelling with porch addition, 32' (three bays) x 24' (one bay). Gable roof covered with asphalt shingles, open eaves; board and batten siding, windows of no lights with board shutters; foundations of fieldstone granite piers. Plan is two rooms wide divided by central chimney, one room deep. Chimney of brick laid on fieldstone granite foundation; interior never finished. No other structures associated with this site remain. The advanced vandalism and deterioration of this structure has eliminated much of the original fabric and integrity, which would hamper any preservation of the structure.

This structure is a typical example of a tenant farmer or homestead dwelling of the late nineteenth and early twentieth century, and may be seen throughout the project area and the Southeastern United States. The significance of this structure as an example has been greatly lessened because of the extreme deterioration of the original fabric.

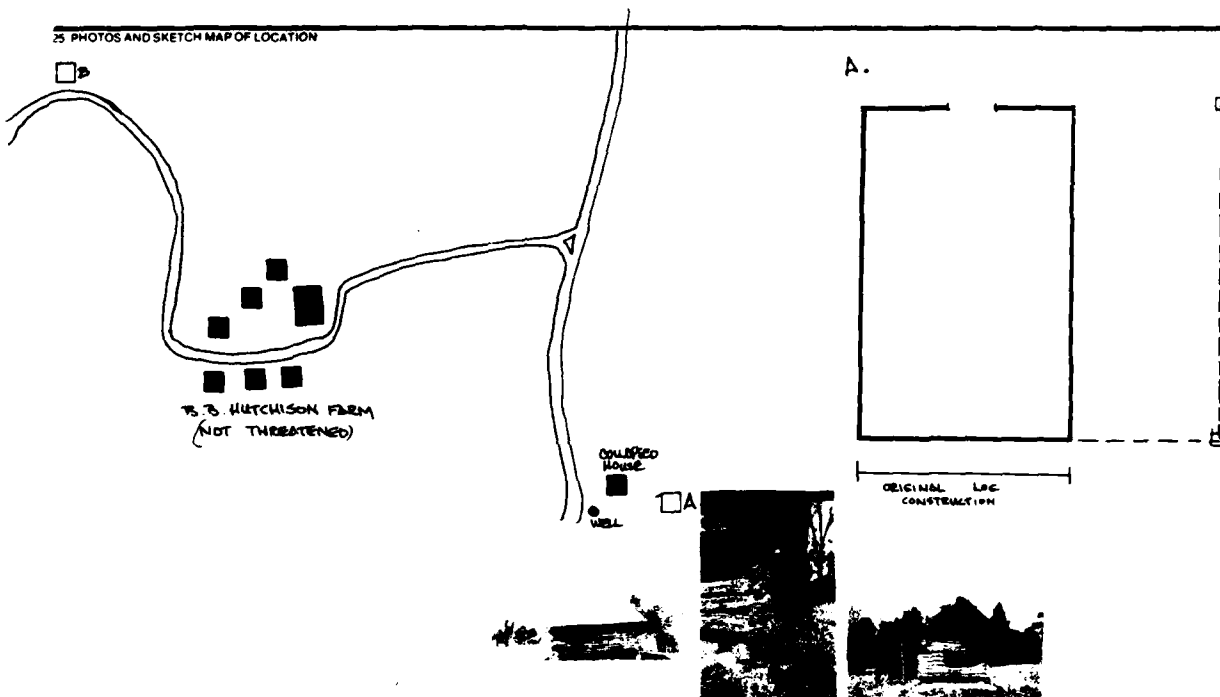
25 PHOTOS AND SKETCH MAP OF LOCATION

Significance This structure was recorded due to its unknown status within the project area. Except for this site and site AB1101-1B, the B. B. Hutchison farm complex is not threatened by the Richard B. Russell Project, and was therefore not recorded. This structure is an excellent example of the survival of log construction in this area during the nineteenth century. The use of V - notch joinery indicates a late nineteenth century date. The small size, two story height of the structure and its overhanging roof are unusual architectural features in the project area. The barn is well preserved, but is deteriorating rapidly and threatened with collapse.

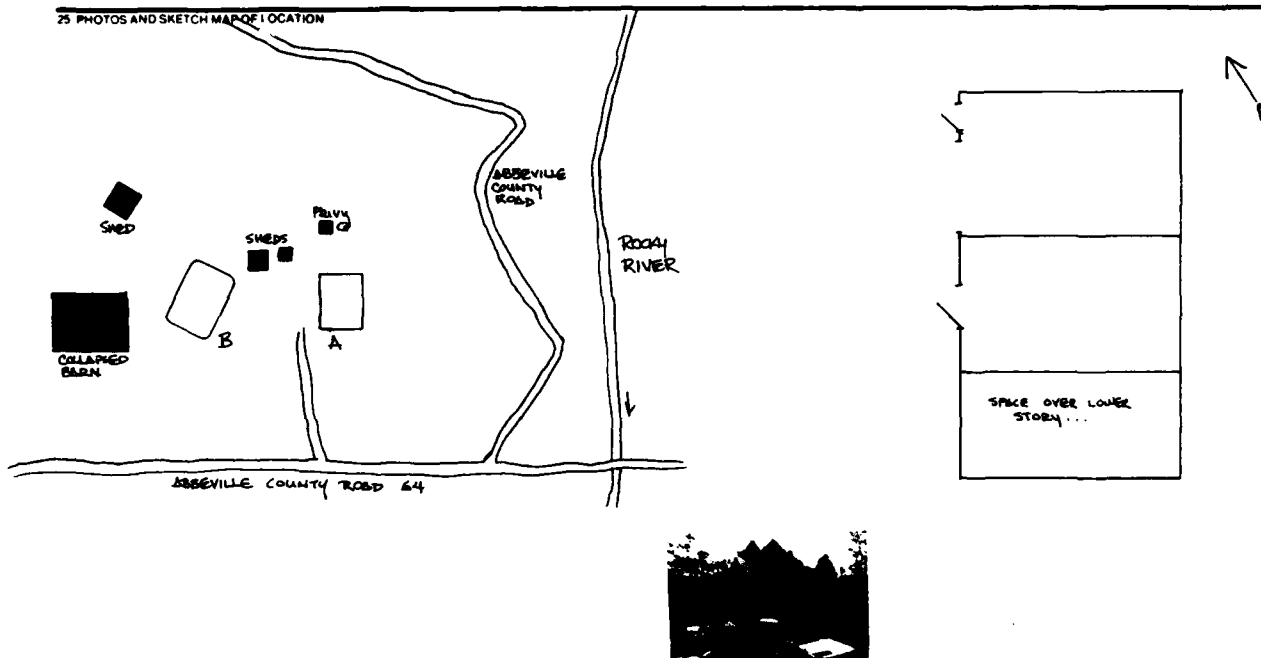
Balloon frame embankment barn with loft and post and frame shed addition, 36' X 20'. Gable roof and shed roof on addition, covered with sheet metal; clapboard siding; foundations of fieldstone granite piers. This structure is contemporary with an associated house and five additional small outbuildings, CA. 1930-1940 (not recorded). This structure is in a poor state of repair, indicating that its preservation would be a difficult undertaking.

This is one of three known embankment structures in the project area. It is not known how prevalent such structures are in the surrounding region.
